DOT US Department of Transportation
PHMSA Pipelines and Hazardous Materials Safety Administration
OPS Office of Pipeline Safety
Western Region

Principal Investigator Peter J. Katchmar
Regional Accident Coordinator Peter J. Katchmar
Region Director Chris Hoidal
Date of Report 11/07/2012
Subject Failure Investigation Report – TransCanada/Bison Pipeline
Natural Gas Transmission Release near Gillette, WY

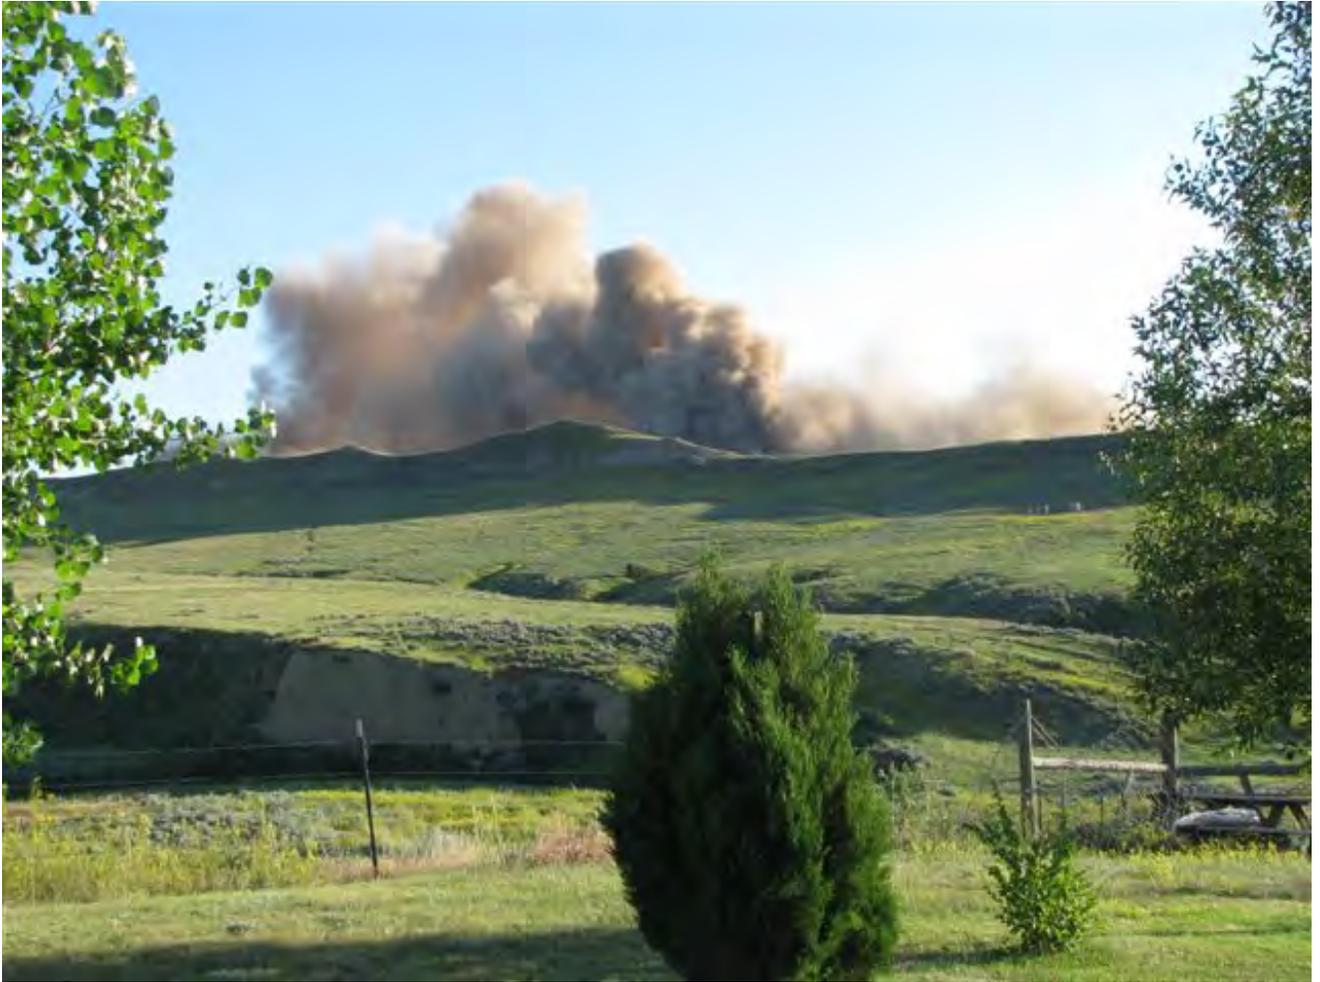
Picture from Landowner's House immediately after rupture.

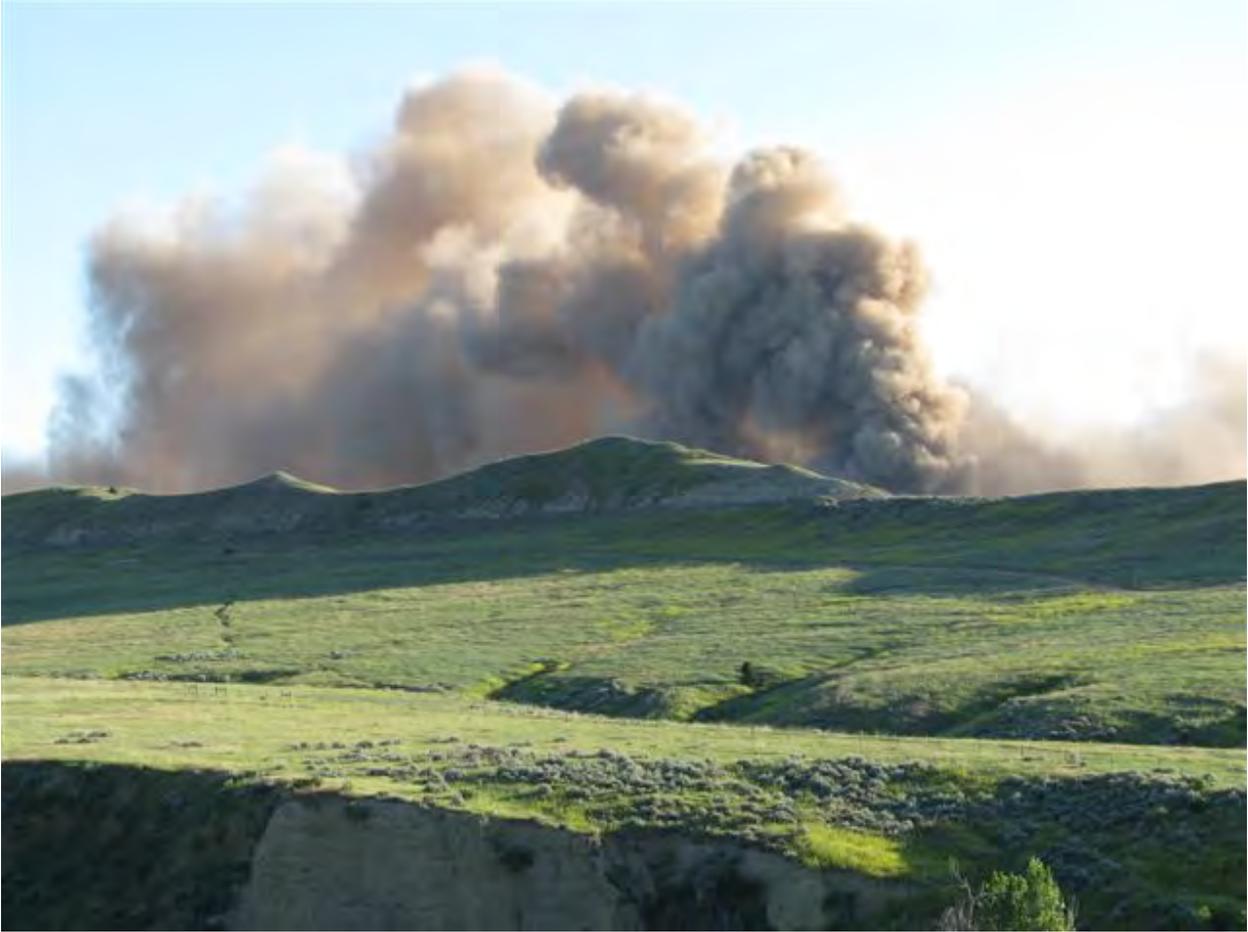
Picture from Landowner's House immediately after rupture.

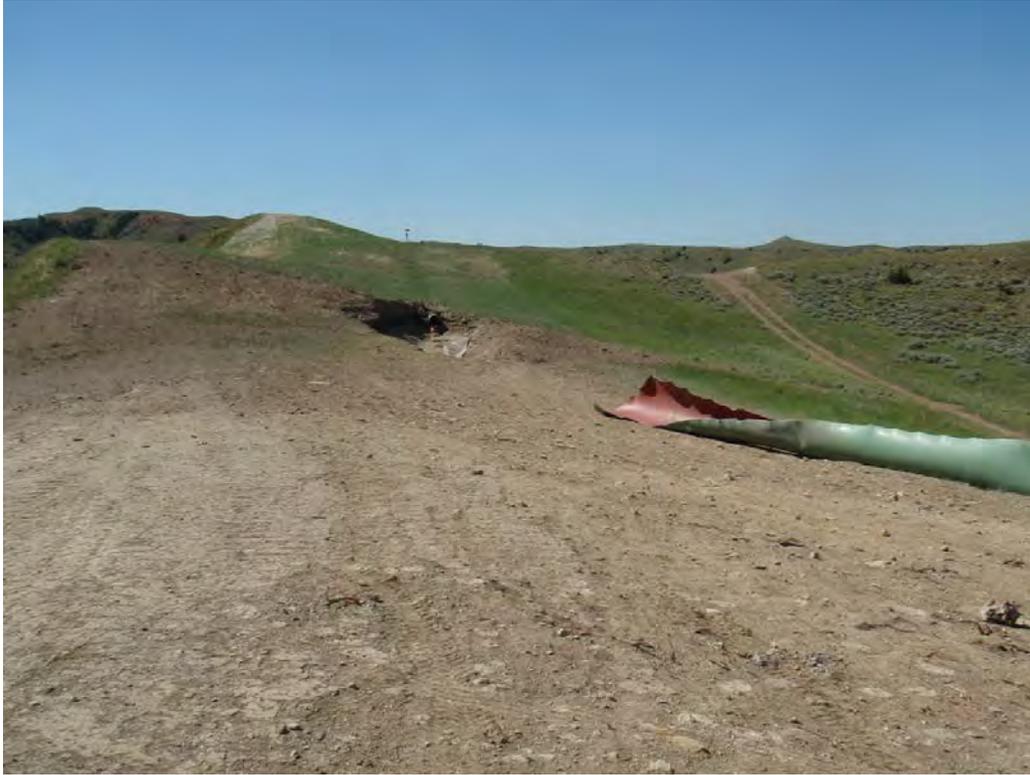
Looking South from Rupture with long piece of ejected pipe in the foreground.

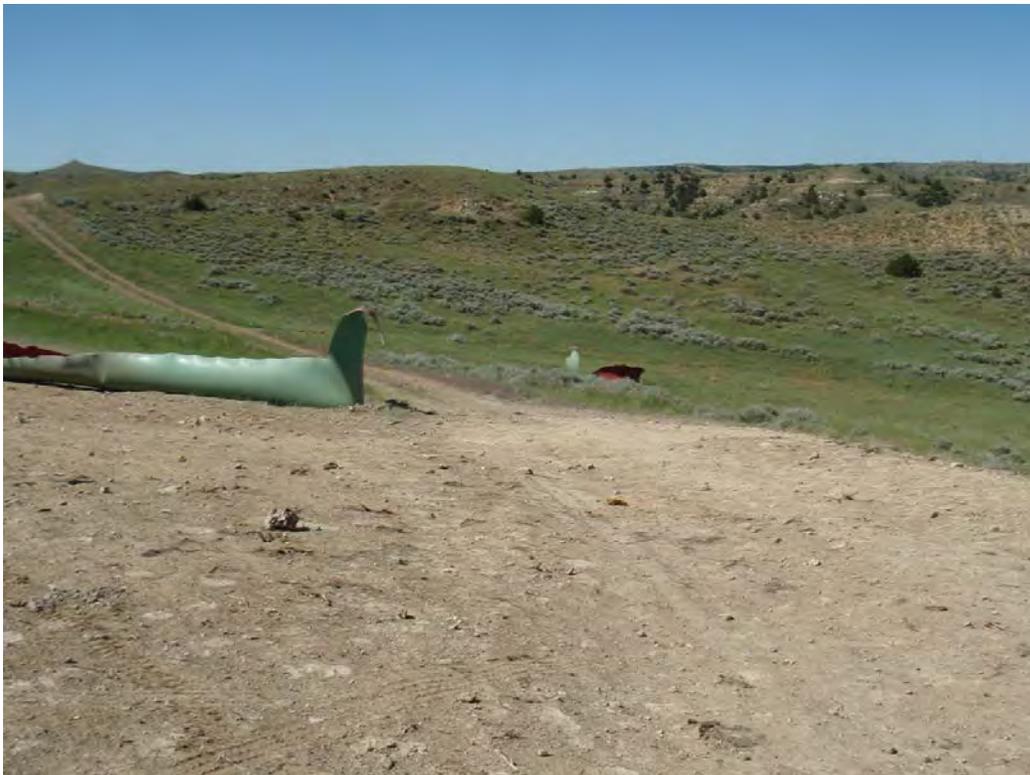
Looking North at Rupture Location with long piece of ejected pipe in the foreground.

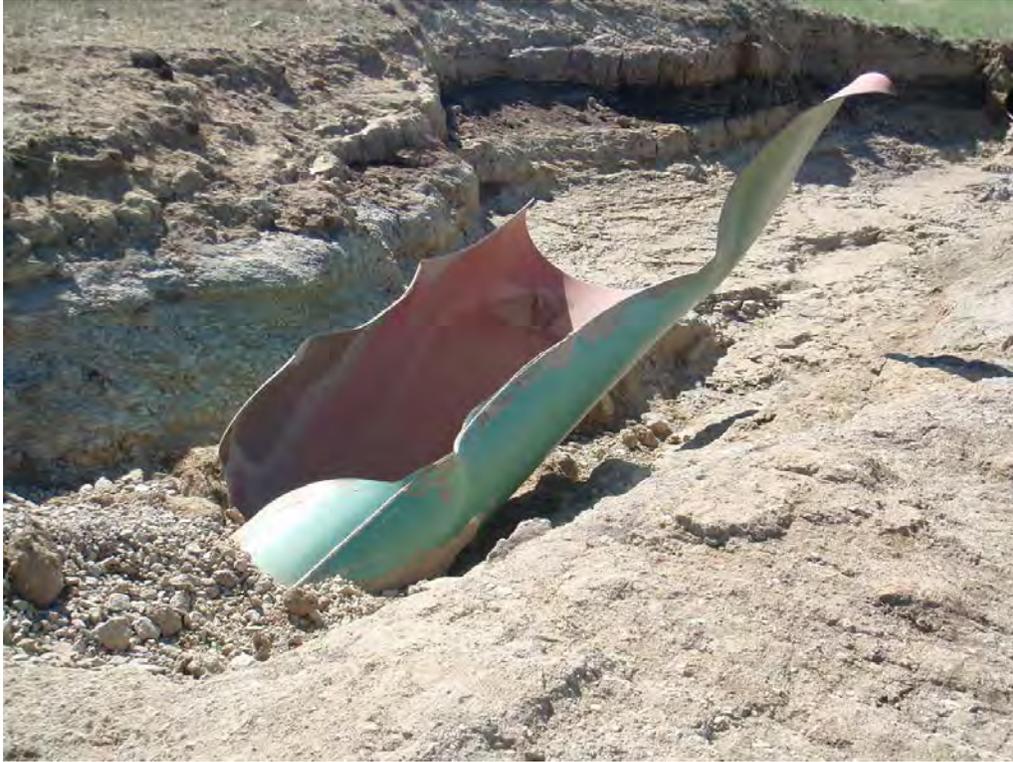
Close up of North end of failed pipe looking SE

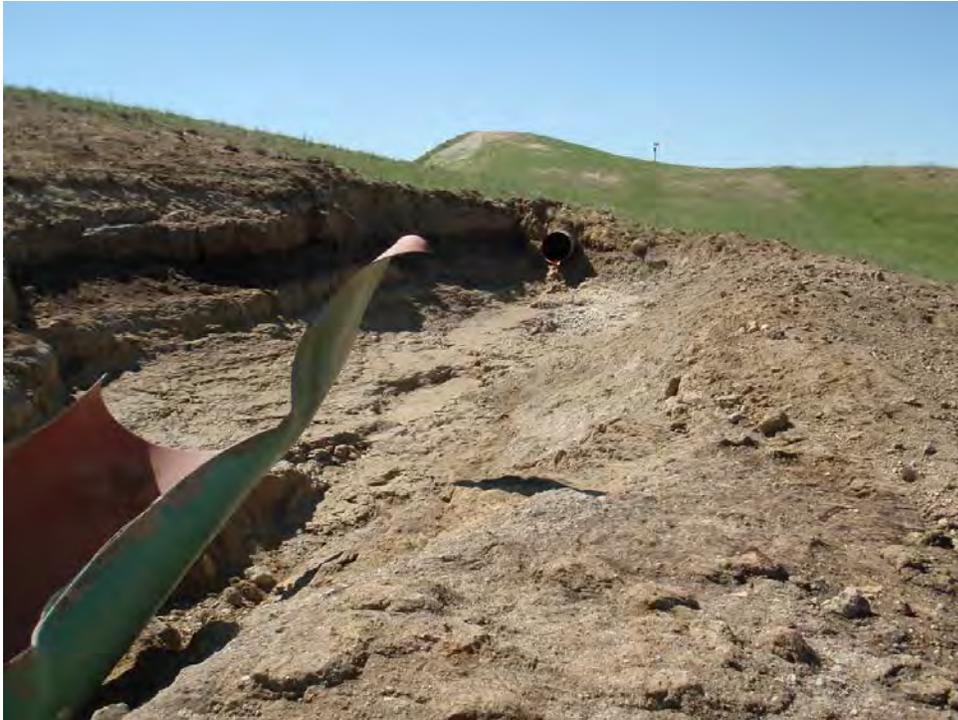
Full rupture crater looking South

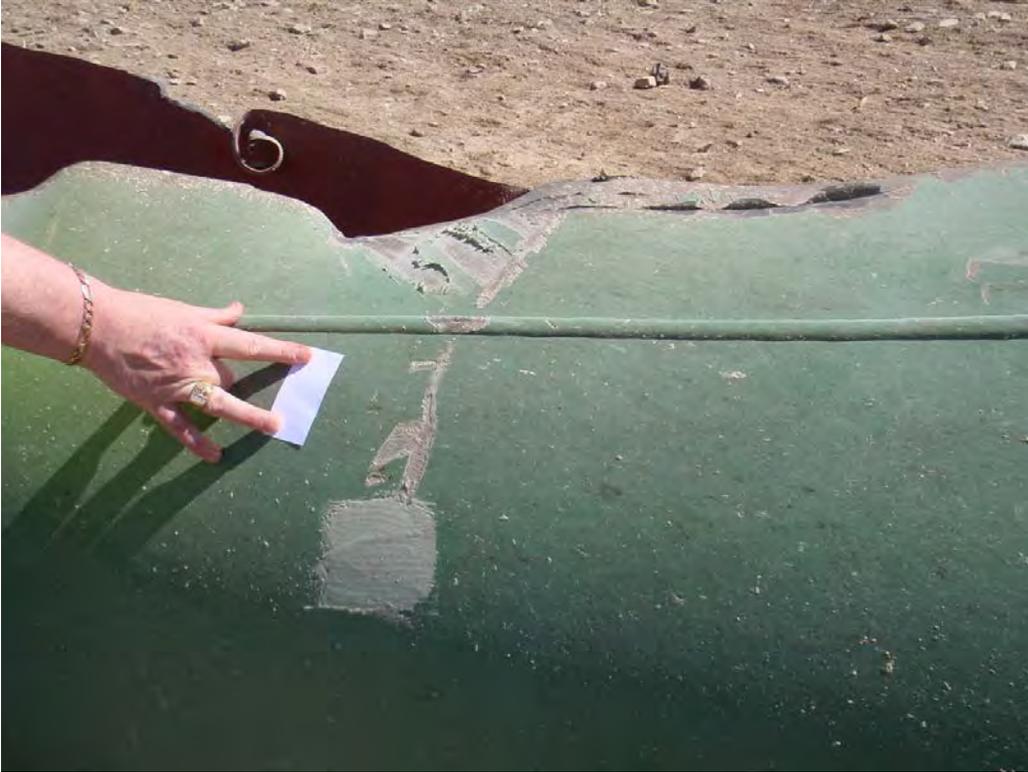
Coating repair and additional external damage (post rupture) on long piece of ejected pipe.

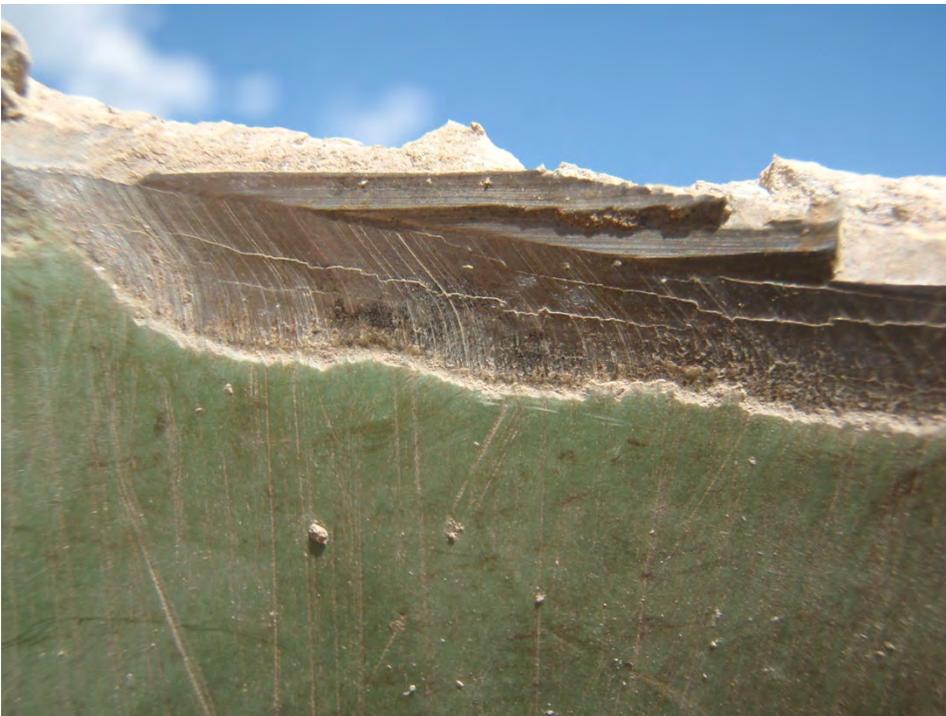
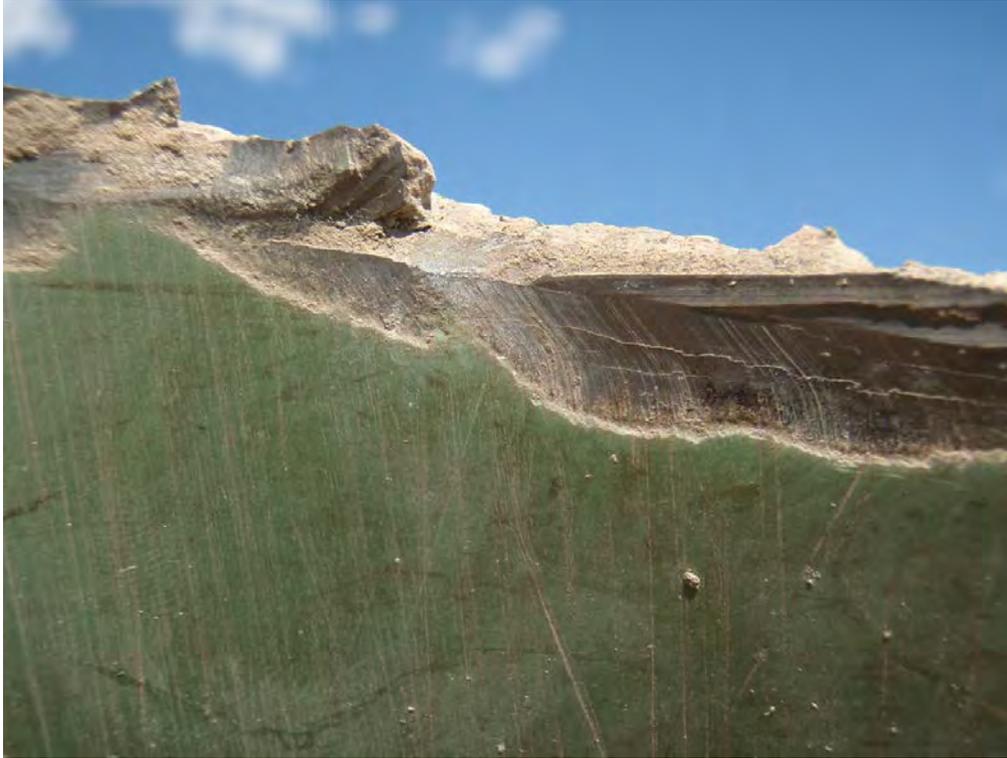
A few hours after PHMSA arrived on site, a metallurgist from TransCanada arrived at the site. The metallurgist and the PHMSA representative conducted a combined review of the failed pipe's fracture surface. The metallurgist indicated that the failure involved a classic 45 degree shear fracture on both ejected pipe fragments and the two arrest ends. He indicated that that fracture mode is indicative of high steel toughness. A number of abrasions on fracture surfaces were interpreted to be secondary abrasions that occurred during the failure event as the pipe came through the ground and landed. He also identified a location where he observed an area of flat fracture that coincided with mechanical damage that he thought might be the origin of failure. He cleaned the fracture surface with water and a tooth brush and photographs were taken of that area as well as the other probable mechanical damage pipe a few feet away. The fracture at the probable origin of failure was observed to have a 'woody' morphology and to have a dark stain line on the surface with a curved profile resembling a possible crack arrest line. The metallurgical laboratory concluded later that the length of the dark stain line was measured to be 4.5" long with a maximum depth of approximately 0.372- inch (89%) of wall thickness. Based on the positions of the long seam welds on the arrest ends and on the elected pipe, the damage was estimated to be located on the top of the pipe at the 10:15 o'clock position (looking

In summary, the root cause for Bison pipeline rupture was severe mechanical damage in the form of a gouged dent containing cracks. Hydrogen played no role in the Bison failure incident. The mechanism for rapid crack growth in Bison failure was determined to be purely mechanical. Free of corrosion and corrosion scale on the fracture surfaces indicates that the Zone 2a was not formed by progressive propagation of the initial crack during six months operation; instead it reflects a large crack increment by ductile tearing due to pre-commissioning hydrostatic testing followed by a pressure cycle from zero to MAOP. This conclusion is supported by fracture mechanics calculations; single edge notched tensile tests, and is consistent with the well documented phenomenon that time-dependent crack growth by slow ductile tearing could occur during hydrostatic test.”

Close up of Probable Failure Initiation showing external damage and visible cracking.

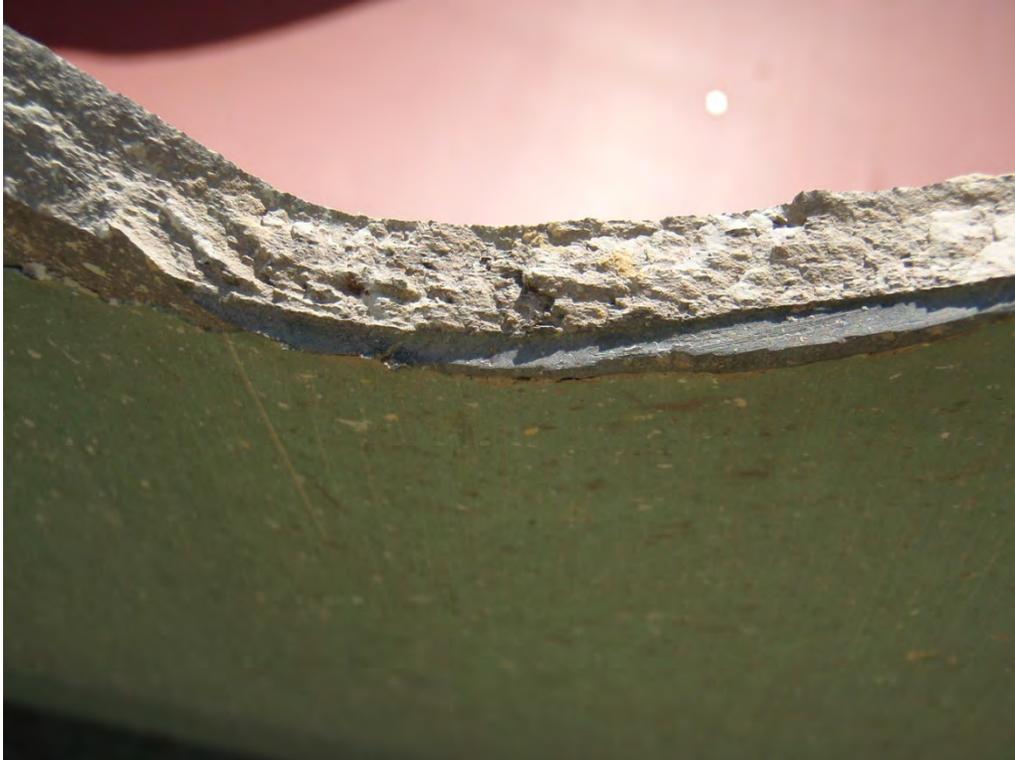
Close up of Probable Failure Initiation showing external damage.

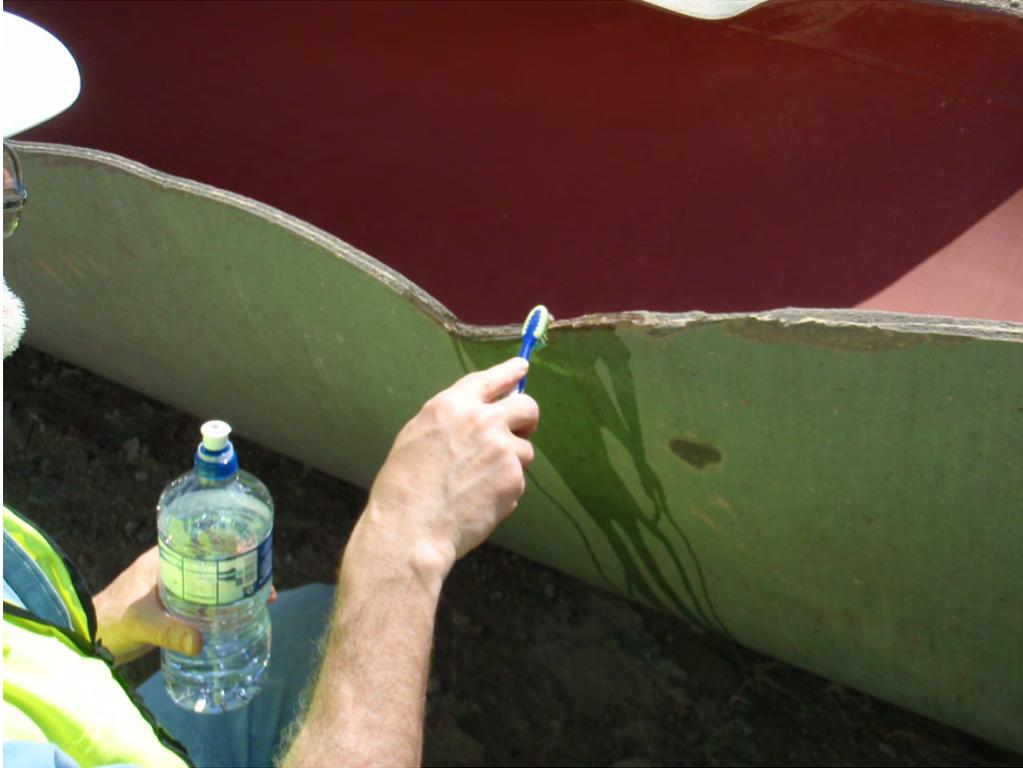
TransCanada Metallurgist cleaning probable fracture initiation point with toothbrush and water.

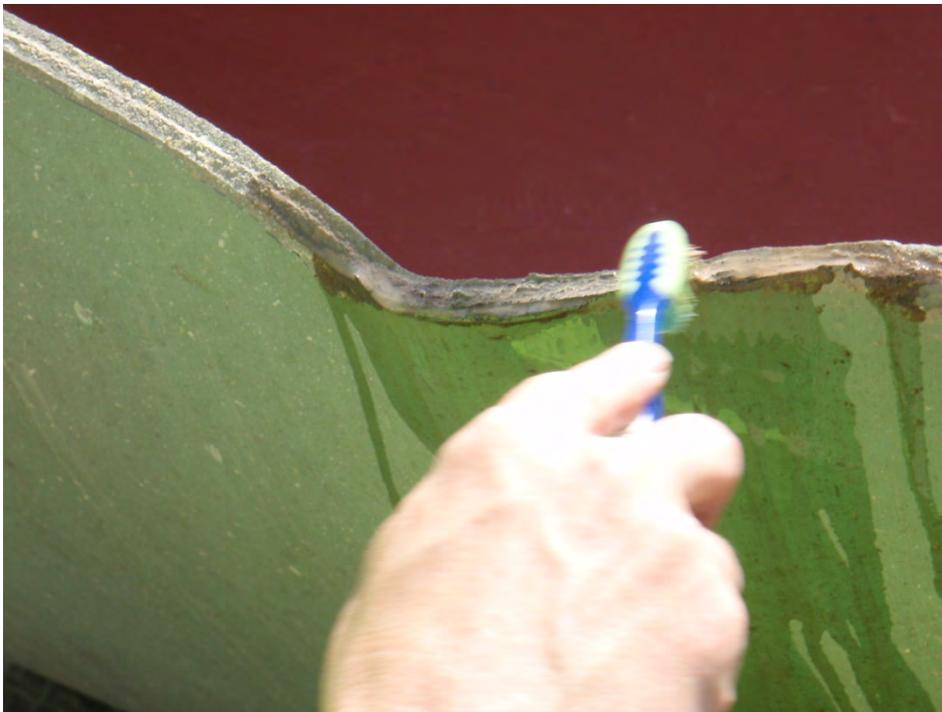
Close-up TransCanada Metallurgist cleaning probable fracture initiation point with toothbrush and water.

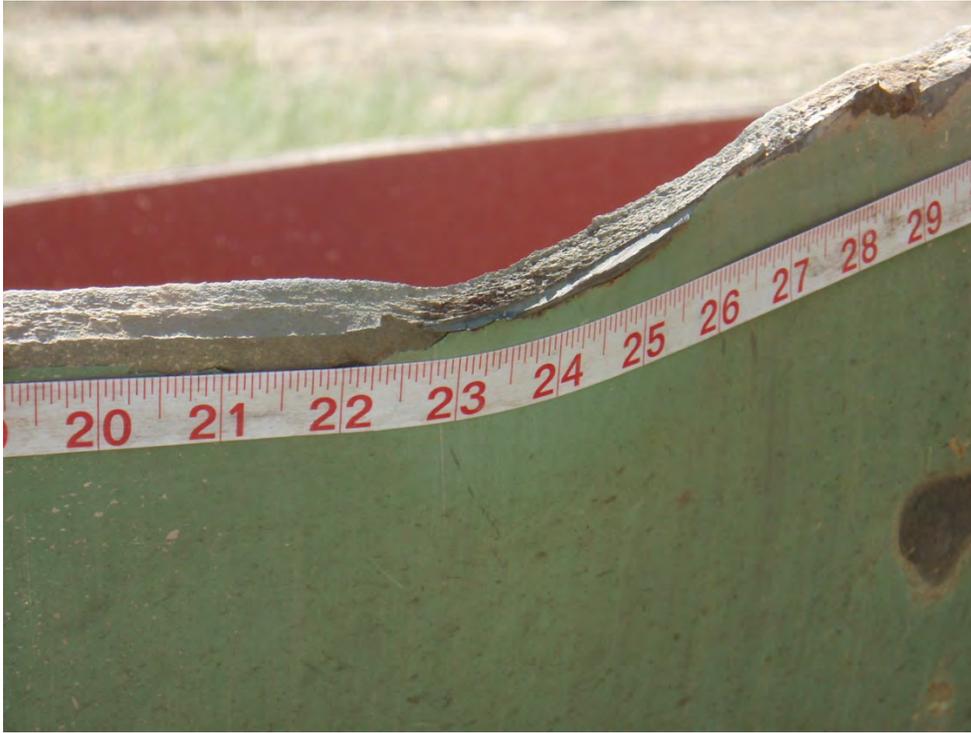
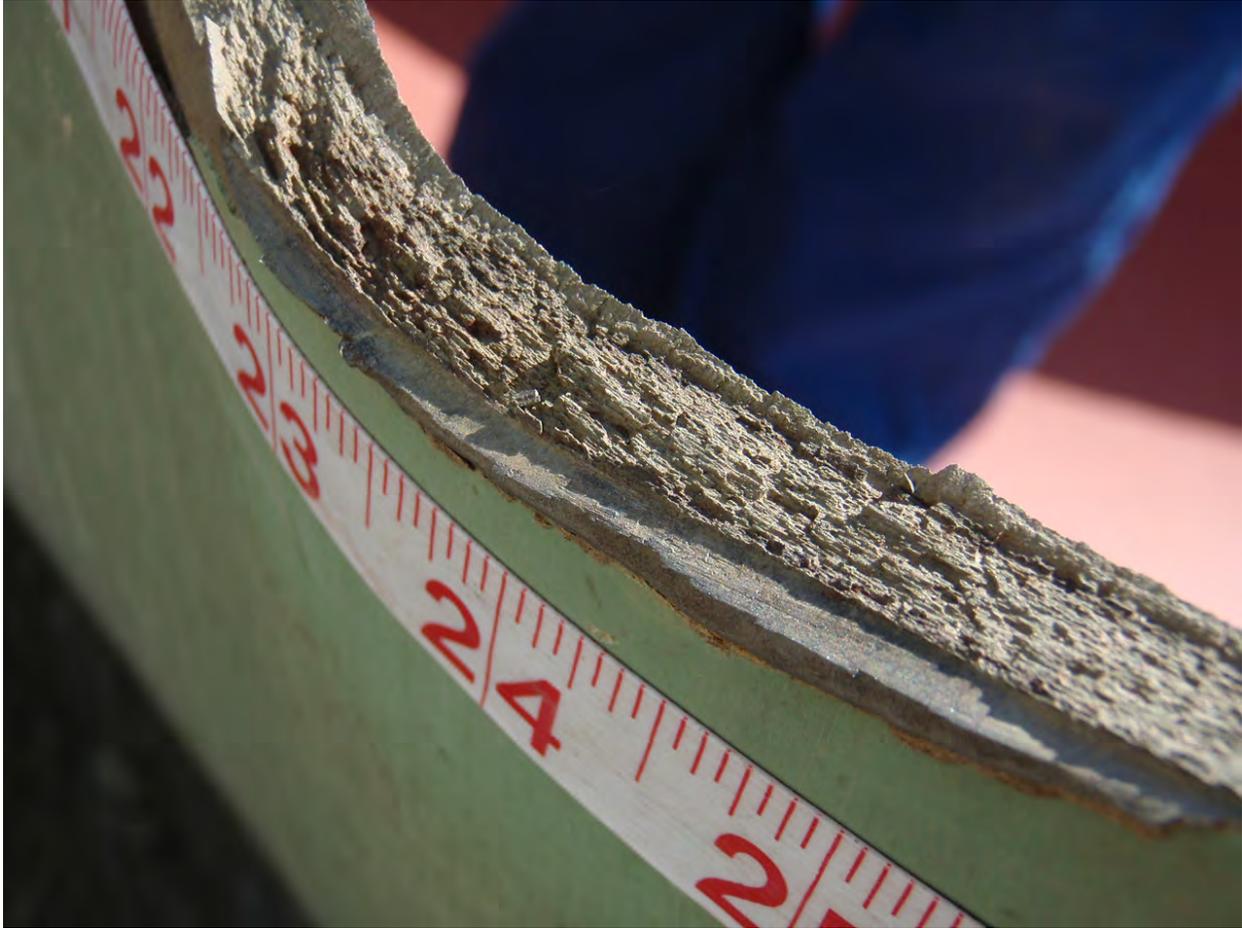
Close-up of probable fracture initiation point after cleaning with measuring tape.

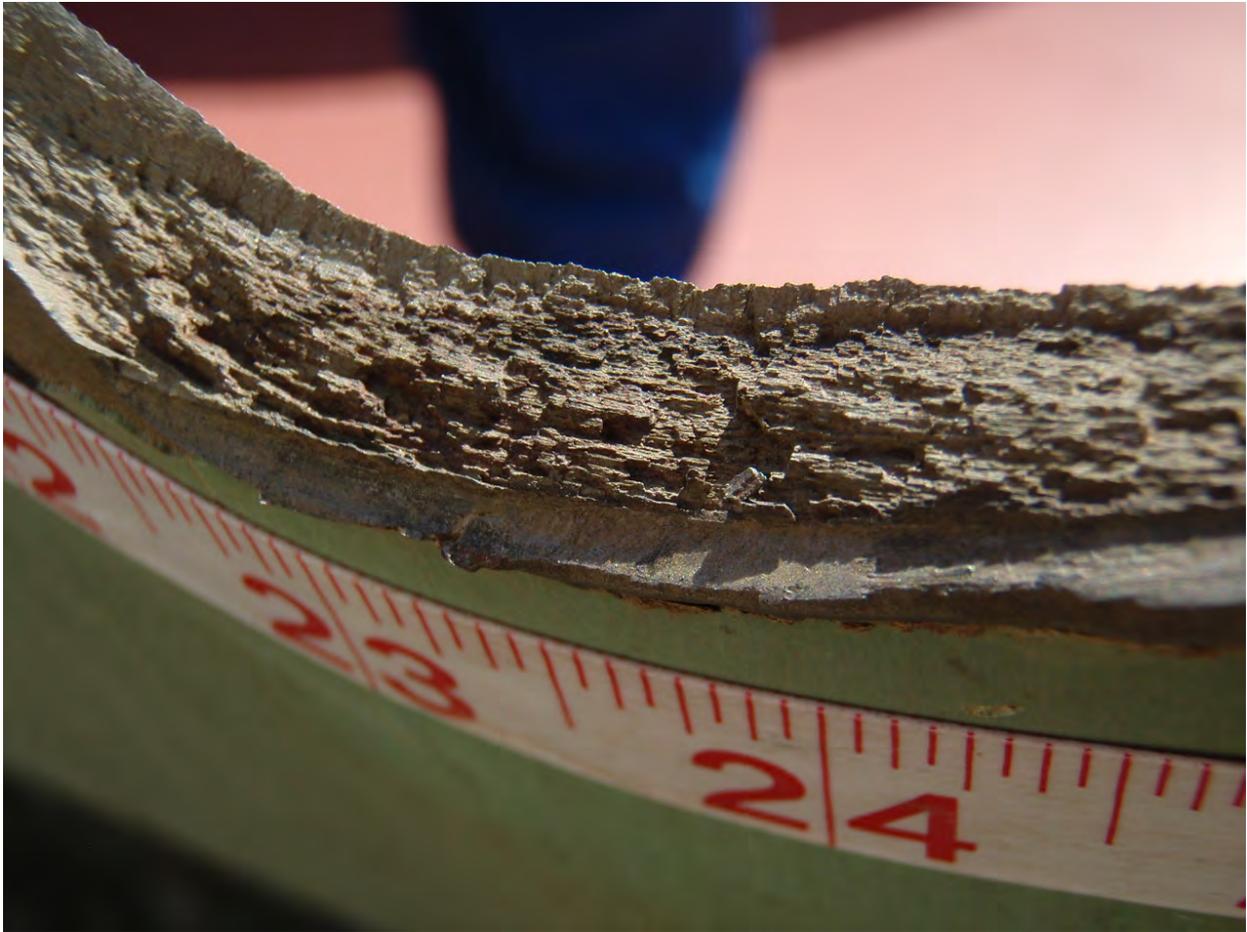
Extreme Close-up of probable fracture initiation point after cleaning with measuring tape.
